USAAVLABS TECHNICAL REPORT 66-55

DIAGNOSTIC NOISE STUDY OF POWER TRANSMISSION SYSTEMS

Final Report

CONTRACT DA 44-177-AMC-249(T)
CURTISS-WRIGHT CORPORATION
CALDWELL, NEW JERSEY

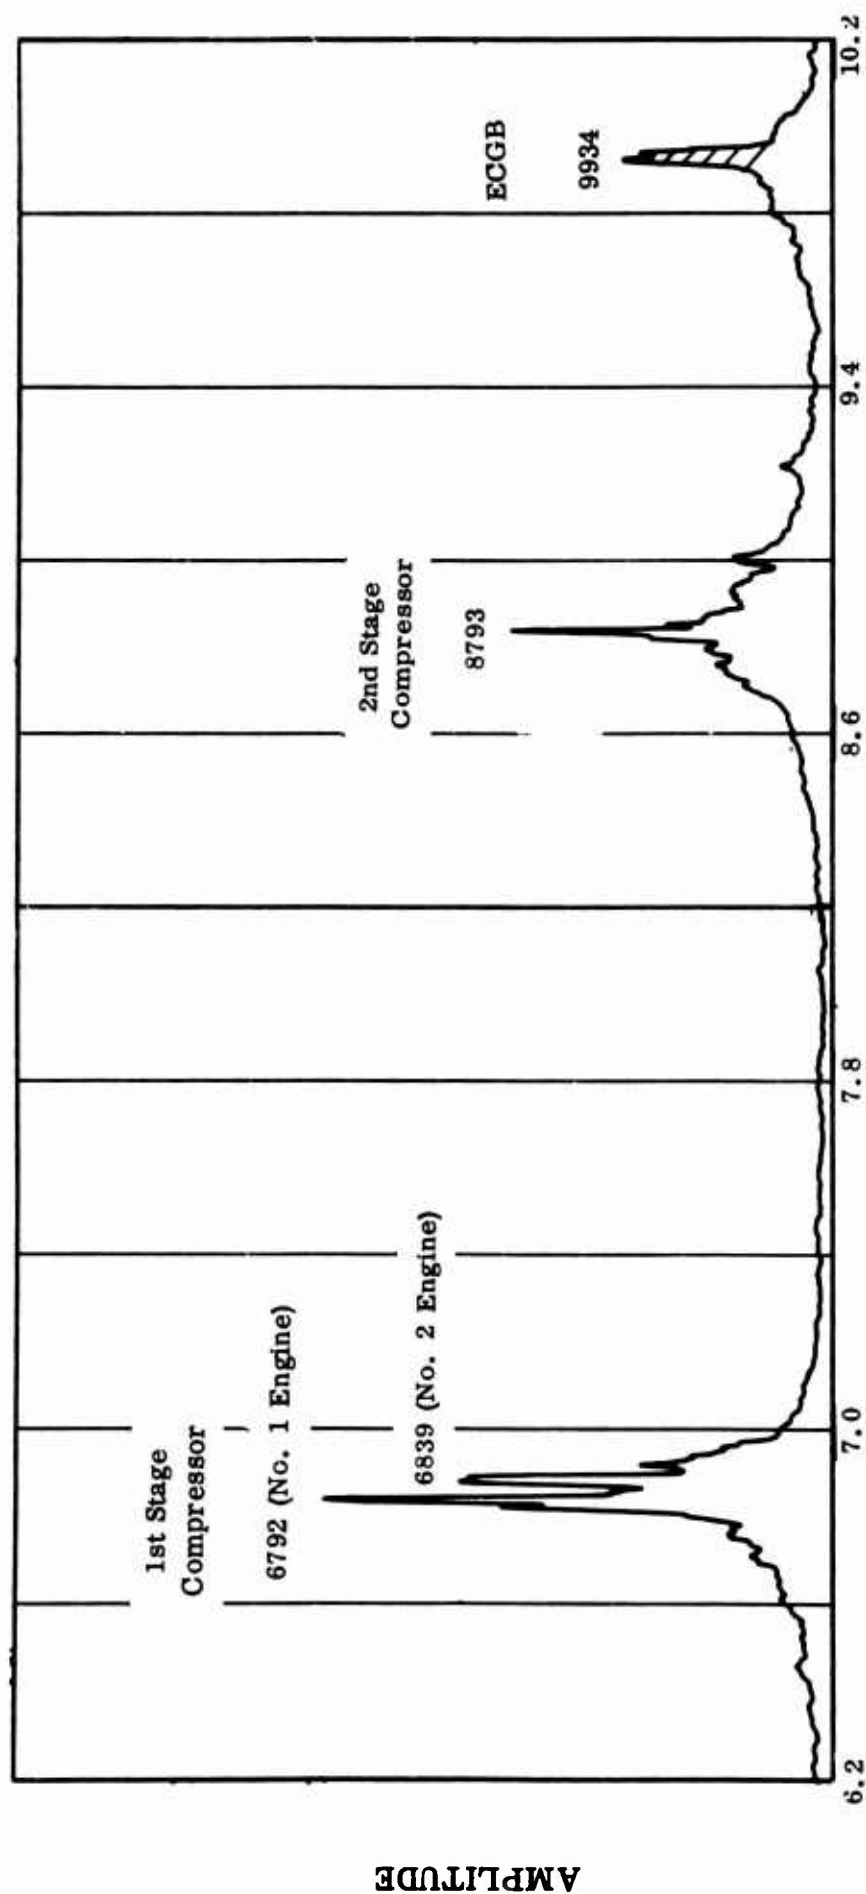
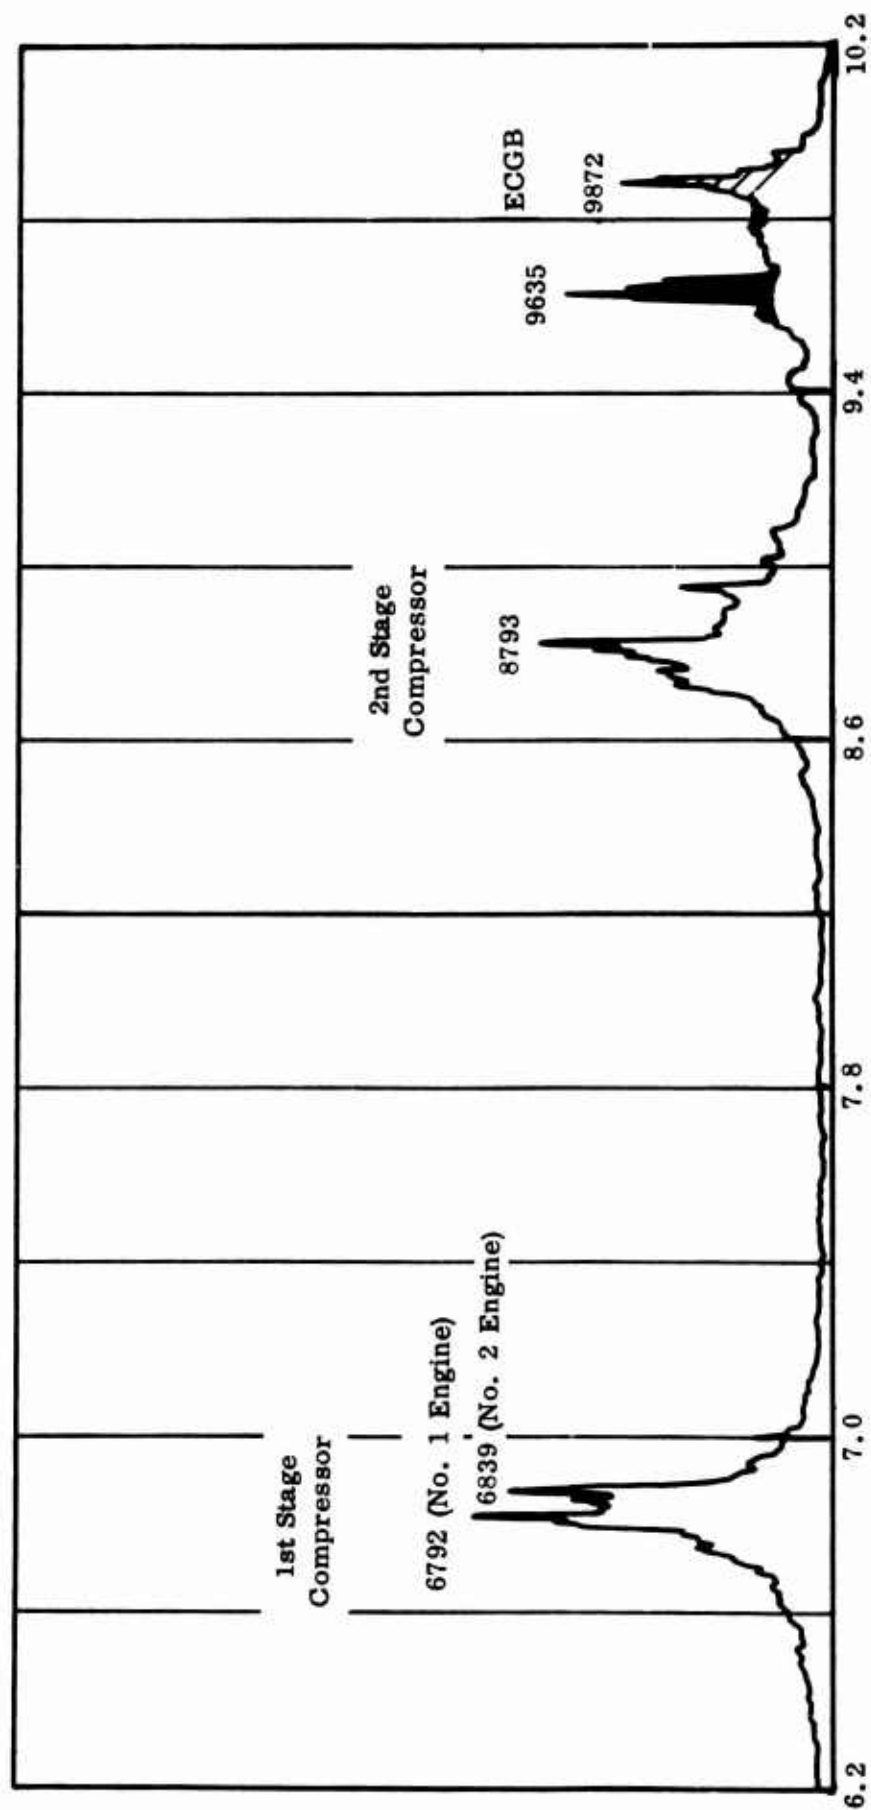
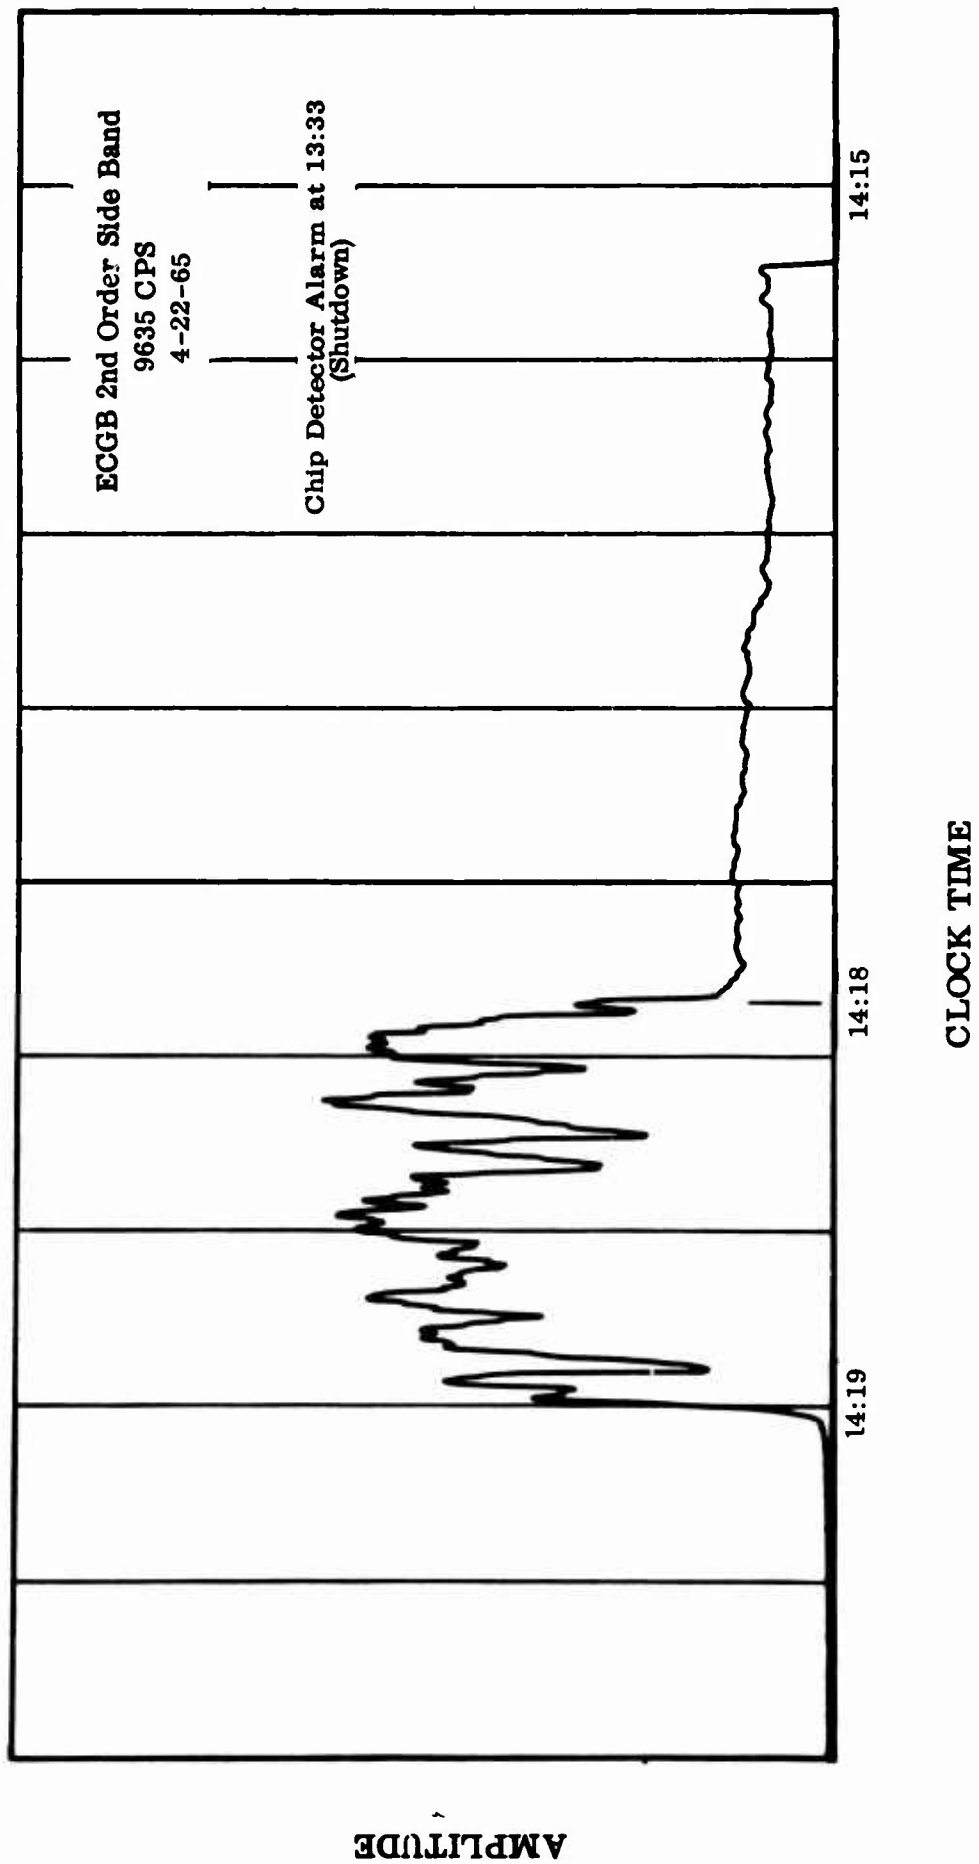
A fatigue failure in the web of the No. 2 ECGB intermediate (idler) gear (see Section IV-A) occurred during the green runs at a total rig time of 328:14 hours. Fortunately, a recording was being made of the ECGB with the engine operating at 14809 N₂RPM at the time of failure. Normally, acoustic recordings are made near "idle" (7000 RPM) because of the increased signal-to-noise ratio. However, the spectrograms produced at this high N₂RPM adequately indicate this fatigue failure.

Figure 12. Amplitude vs. Frequency Spectrogram, Recording No. TC5-7B, Microphone No. 1, (Engine Coupling Gearbox), $N_2 = 14902 \text{ RPM}$, Total Rig Time = 328:14 Hrs.

Figure 13. Amplitude vs. Frequency Spectrogram, Recording No. TC5-7B (End), Microphone No. 1, (Engine Coupling Gearbox), $N_2 = 14809$ RPM, Total Rig Time = 328:14 Hrs.

Figure 14. Amplitude vs. Time Spectrogram, Recording No. TC5-7B, Microphone No. 1,
(Engine Coupling Gearbox), $N_2 = 14809$ RPM, Total Rig Time = 328:14 Hrs.

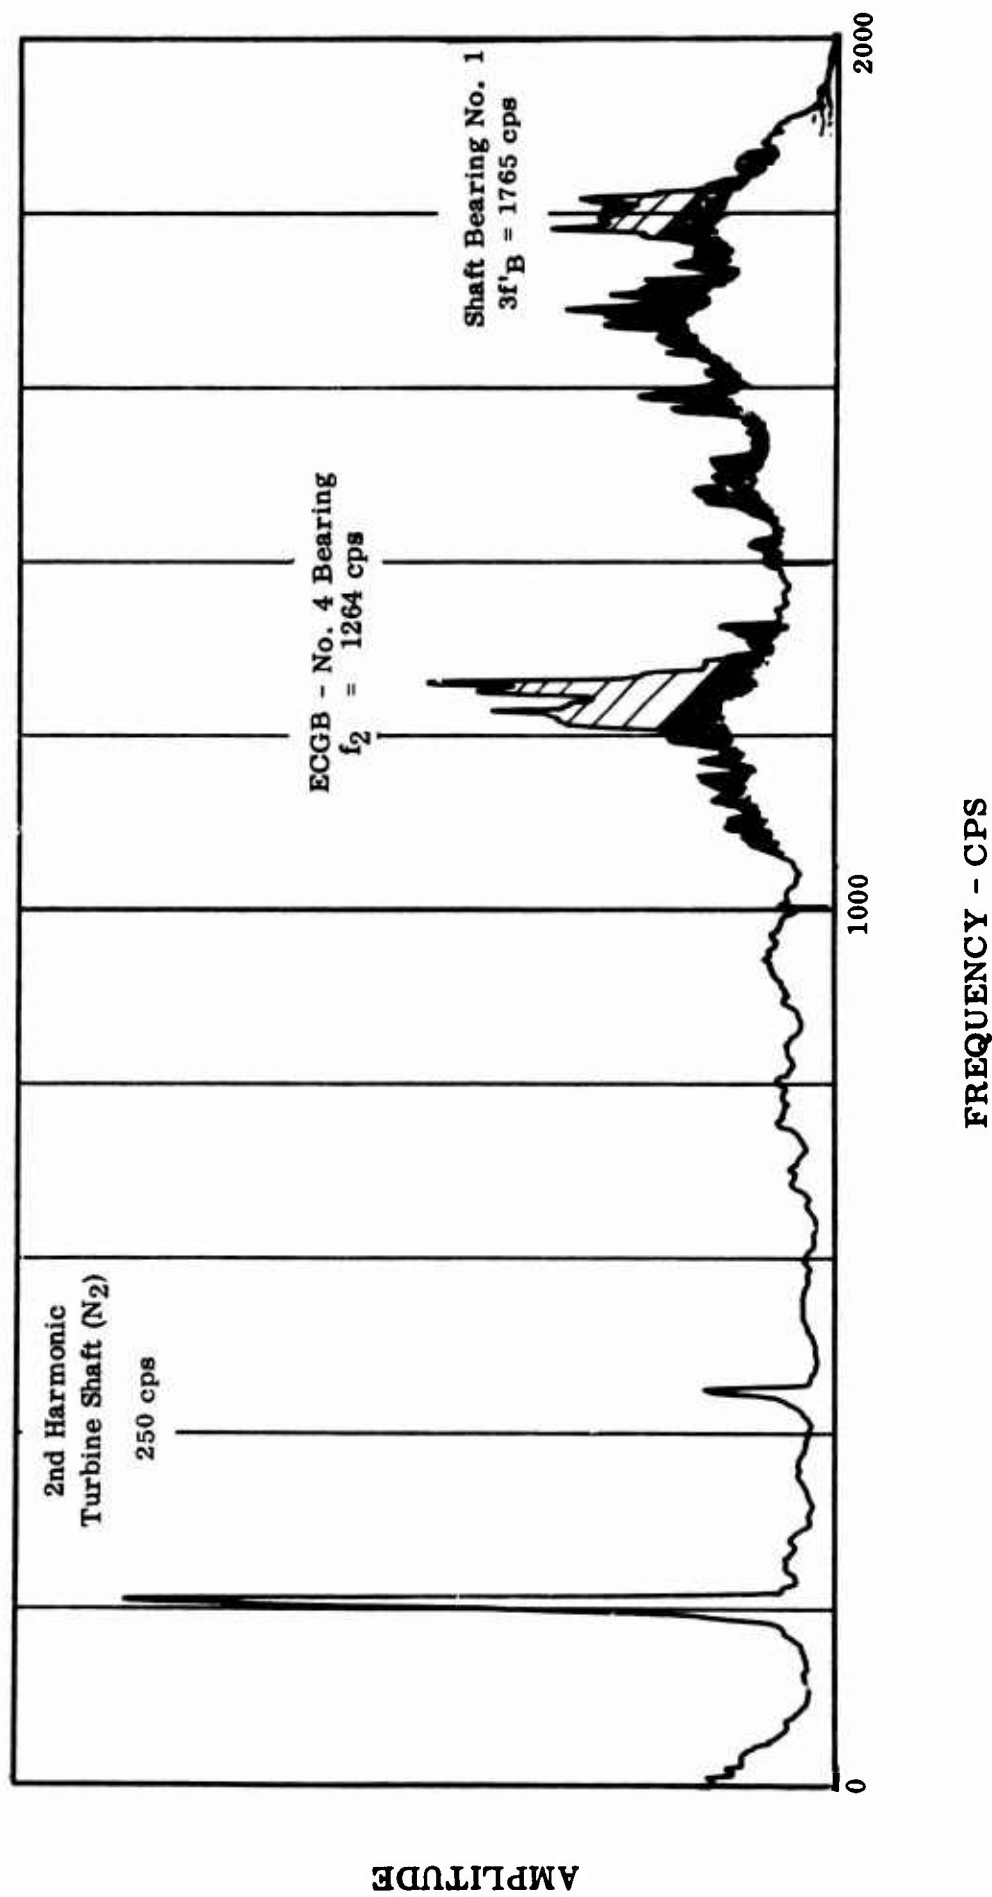
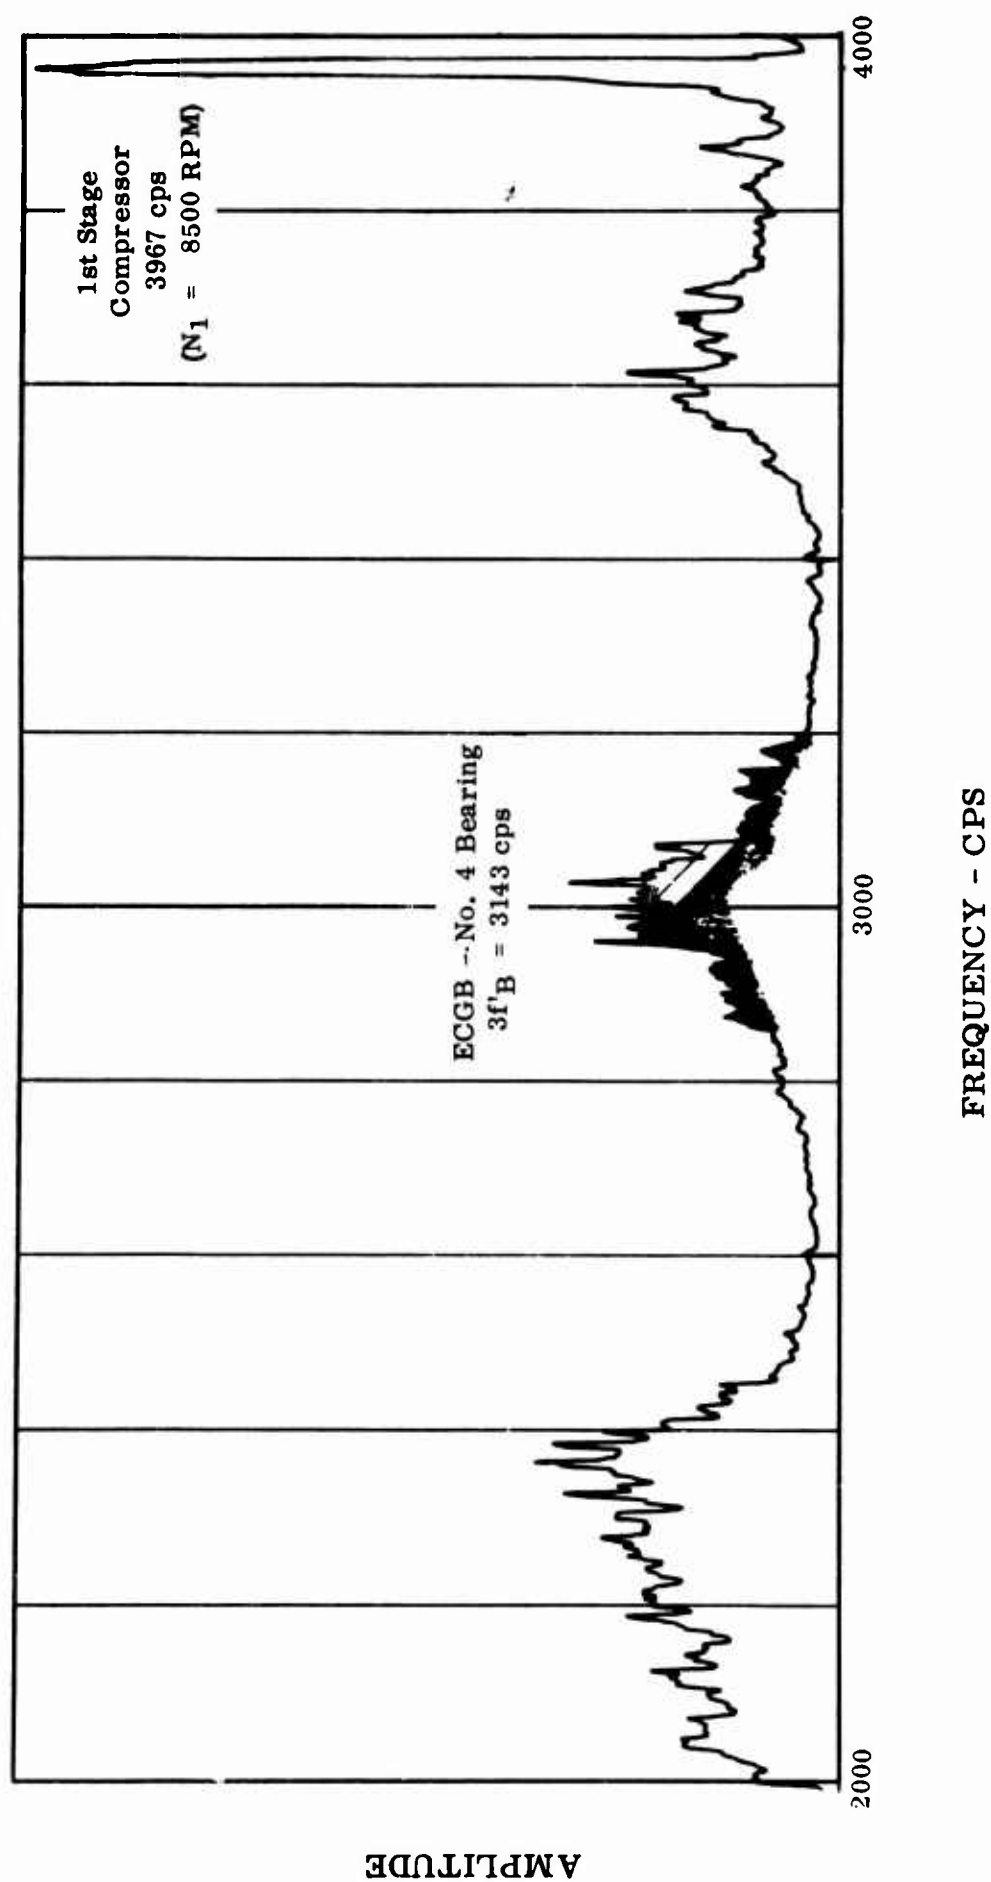
The shaded areas appearing in both Figures 15 and 16 are resonant frequencies which do not change with engine speed. These resonances have subsequently been attributed to the metal cylinder's enclosing the ECGB microphone, which produced an organ pipe effect; thus, a series of resonant humps in the 1K to 4K frequency range resulted. This cylinder was installed to shield the microphone from ECGB oil leaks.

Figure 15. Amplitude vs. Frequency Spectrogram, Recording No. TC19-3A, Microphone No. 1, (Engine Coupling Gearbox), N_2 = 6500 RPM, Total Rig Time = 347:40 Hrs.

Figure 16. Amplitude vs. Frequency Spectrogram, Recording No. TC19-3A, Microphone No. 1, (Engine Coupling Gearbox), $N_2 = 6500 \text{ RPM}$, Total Rig Time = 347:40 Hrs.

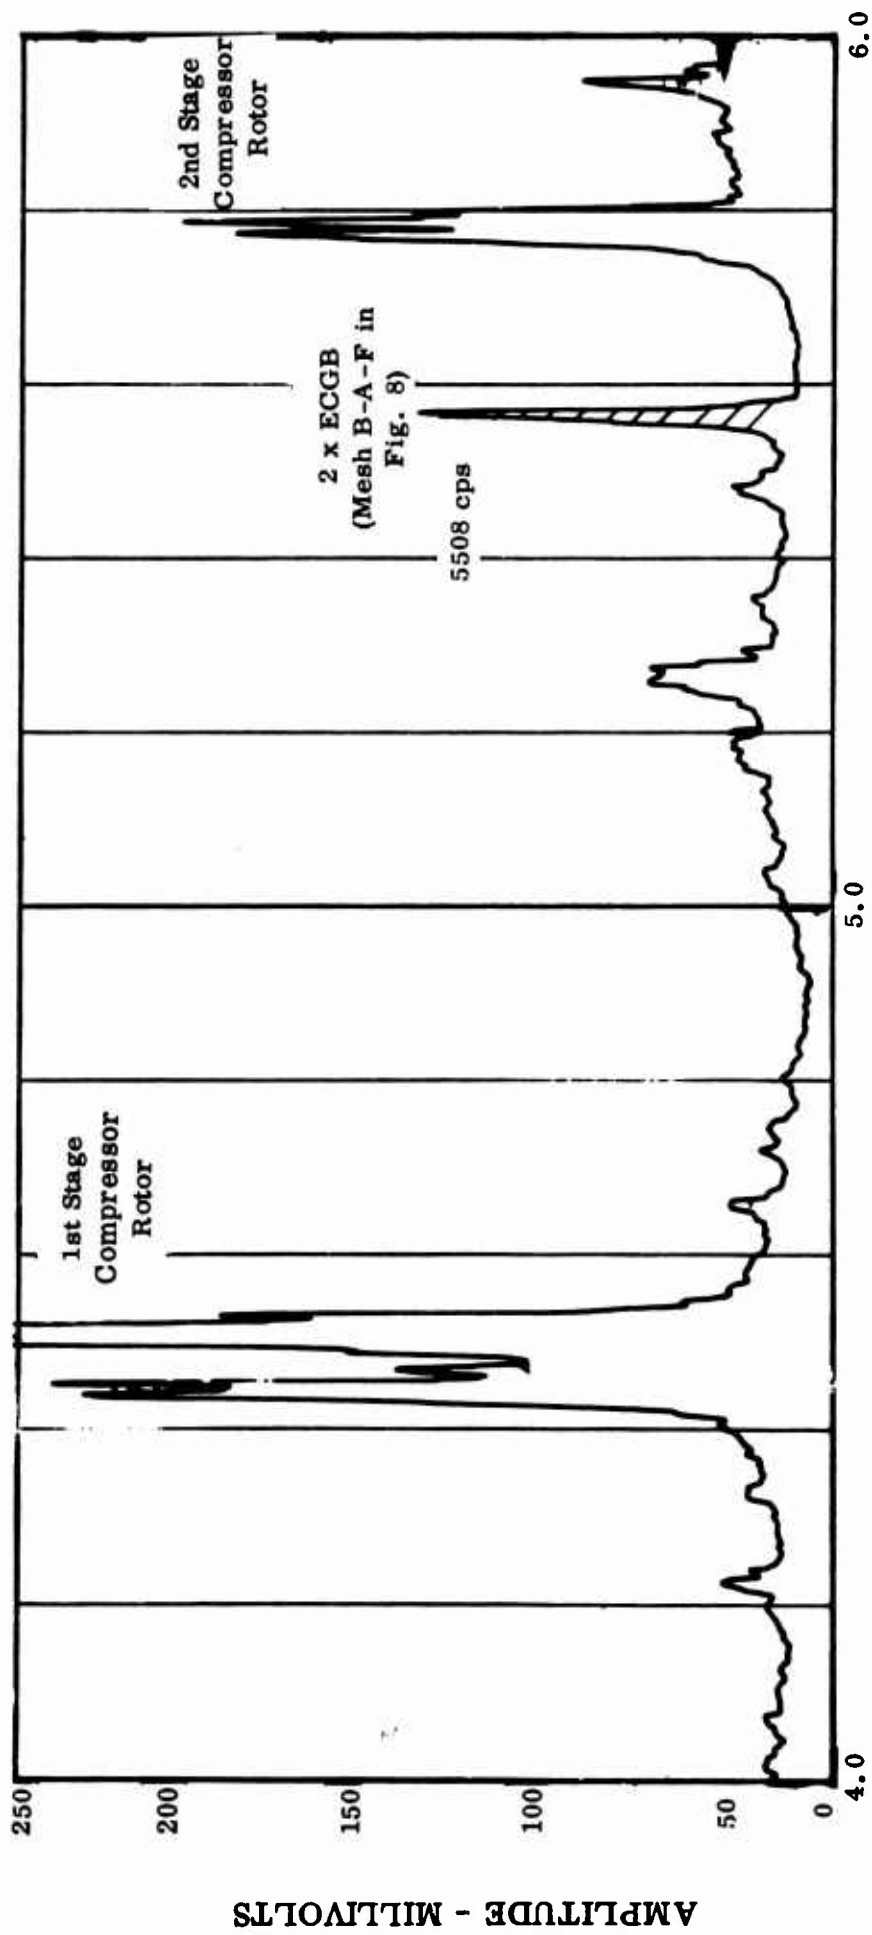
A bearing failure occurring on the small water brake after 10:00 hours of endurance was reflected in the ECGB accessory drive gear mesh frequency. Figure 19 shows the 2nd harmonic of this ECGB accessory drive frequency (cross-hatched signal at 5508 cps). Figure 20, which is a similar spectrogram taken after a new bearing was installed, shows that this signal is no longer present. The actual bearing frequencies were not detected. When this bearing was inspected, the lubricating grease was gone and the bearing was completely rusted, being practically seized on the shaft. This condition imposed an extra load on the shaft and drive gear, which is probably the cause of the high accessory drive gear mesh frequency shown in Figure 19.

Figure 19. Amplitude vs. Frequency Spectrogram, Recording No. TC25-5A, Engine Coupling Gearbox Microphone, $N_2 = 7000$ RPM.

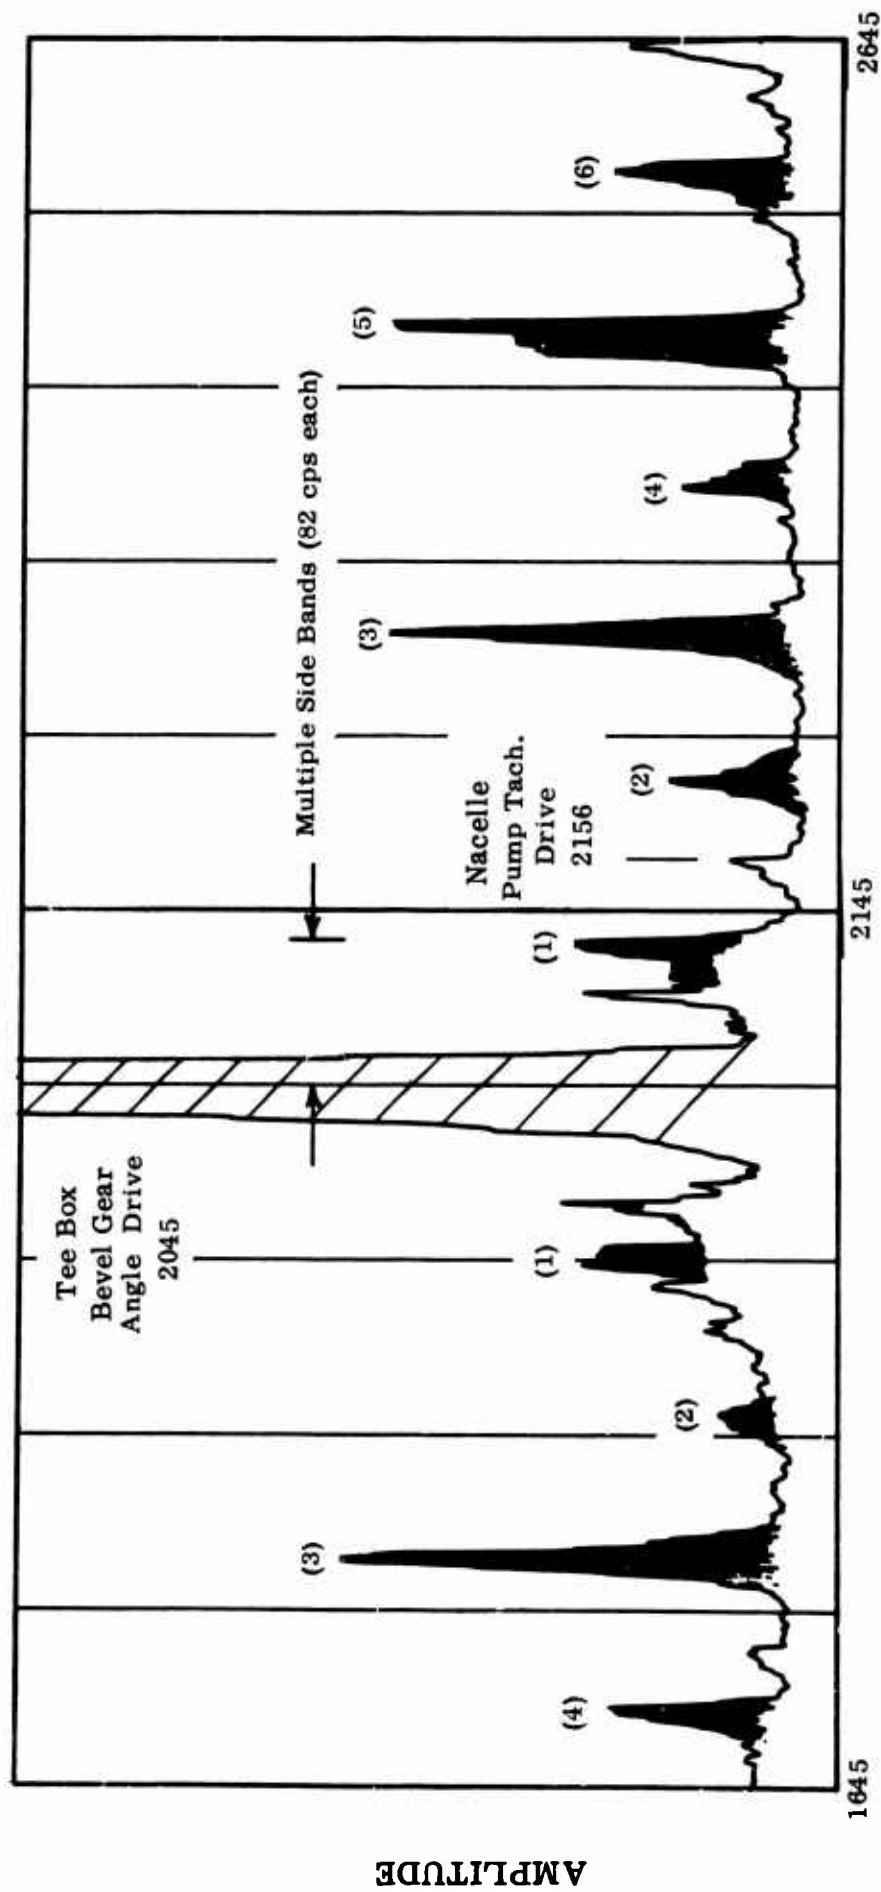
Figure 21 is a spectrogram of the tee box showing multiple side bands around the bevel gear mesh frequency made during green runs (total rig time = 324:58 hours). The existence of these side bands is an abnormal acoustic phenomenon and is usually indicative of an eccentricity or misalignment condition. However, other sources of gear noise which may contribute to these acoustic anomalies are as follows:

Figure 21. Amplitude vs. Frequency Spectrogram, Recording No. TC4-3A, Microphone No. 2, (Tee Box), $N_2 = 14969$ RPM, Total Rig Time = 324:58 Hrs.

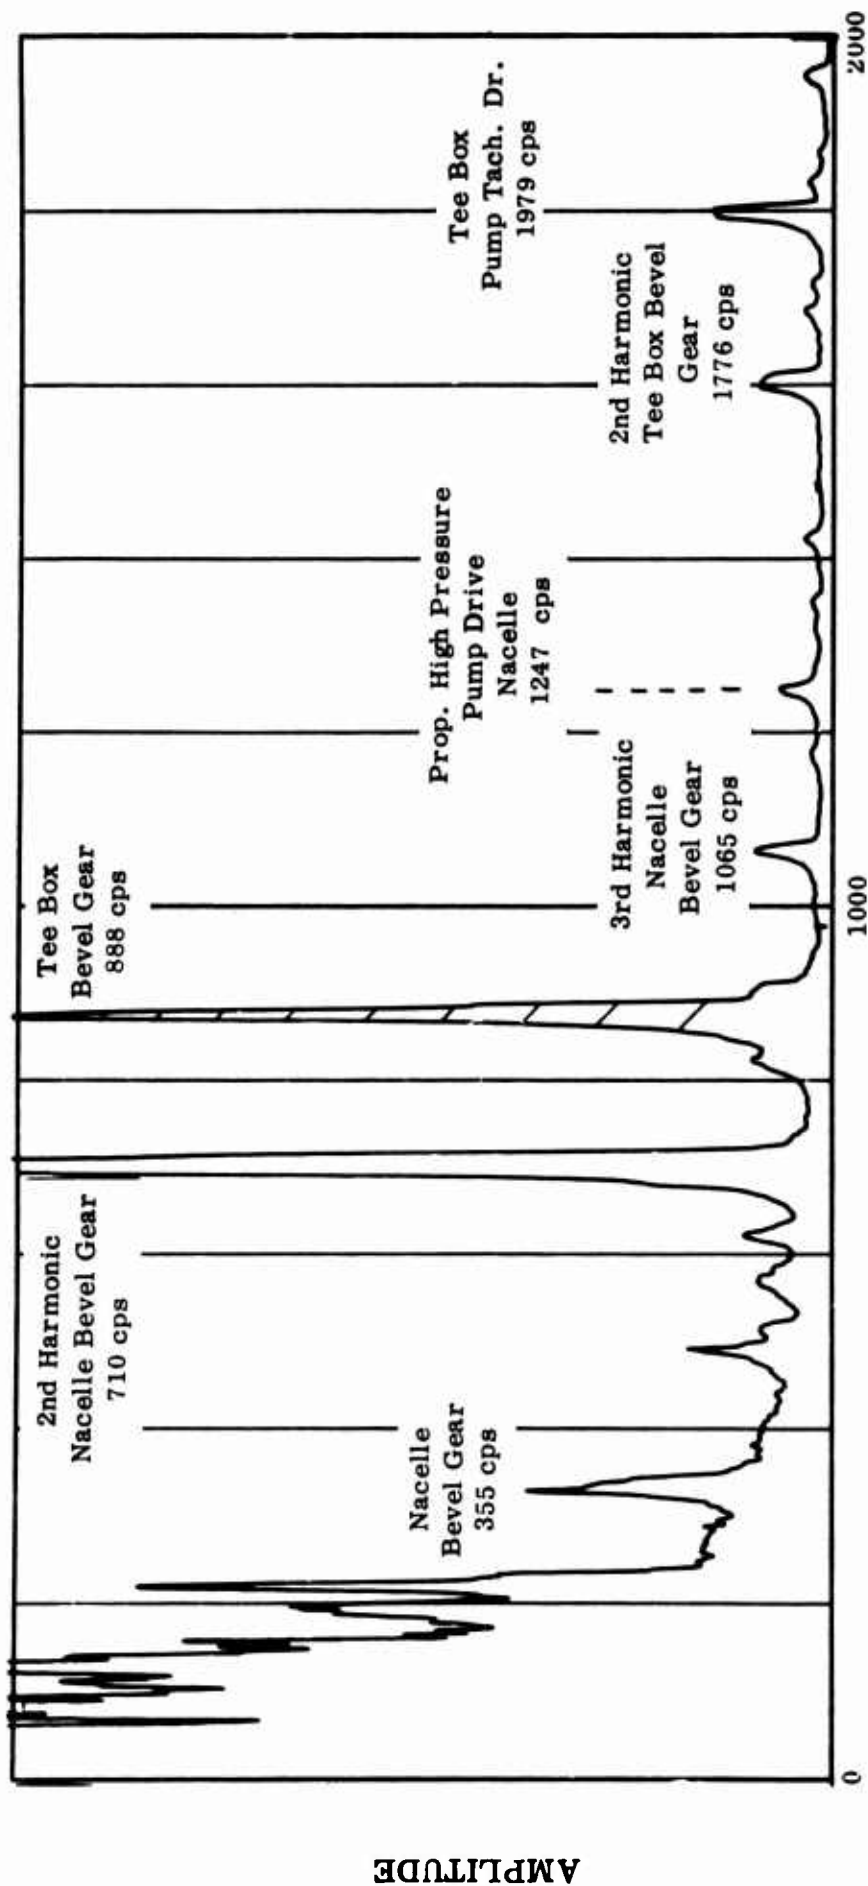
Inspection of the tee box at this time revealed no abnormal conditions. The first recording (total rig time = 347:40 hours) made upon re-assembly showed no side bands (see Figure 22). The only known difference between these recordings is that the gear teeth were probably not meshed with the same teeth as before disassembly. The fact that these side bands disappeared after reassembly of the tee box without any parts being changed could substantiate the misalignment concept, but in any case it indicates a variation in the assembly of the gearbox components.

Figure 22. Amplitude vs. Frequency Spectrogram, Recording No. TC19-3B, Microphone No. 2, (Tee Box), N2 = 6500 RPM, Total Rig Time = 347:40 Hrs.

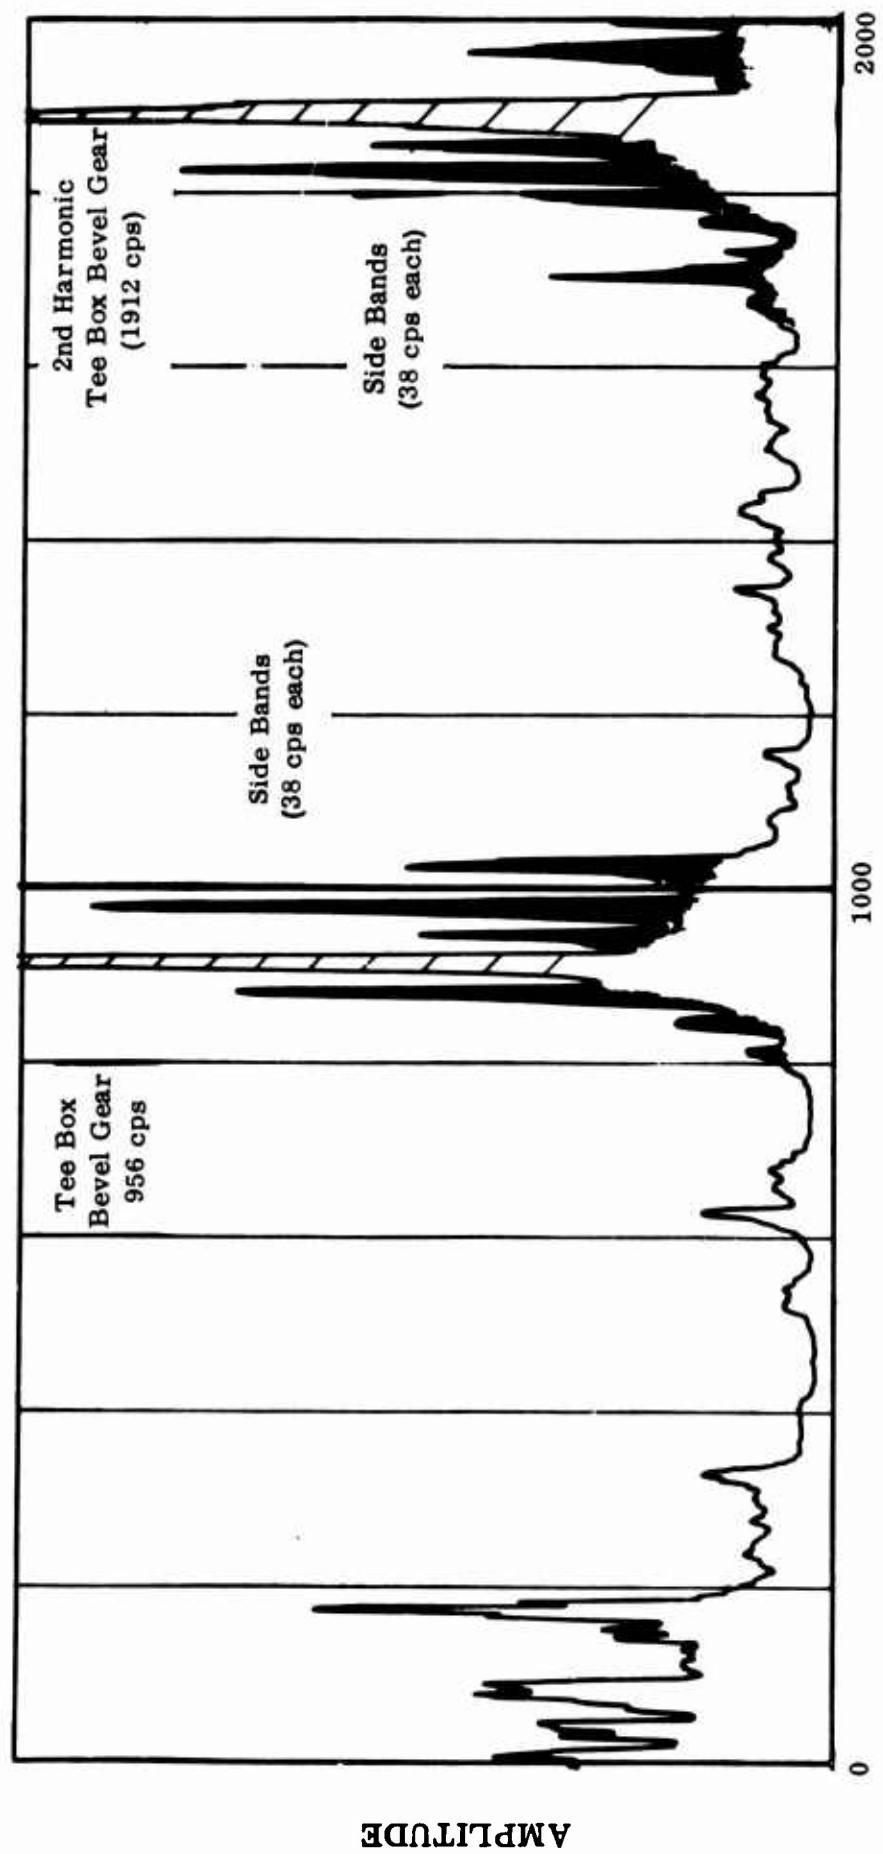
A comparison of Figure 22, which shows a normal tee box bevel gear signal (cross-hatched signal), with Figure 23 shows that multiple side bands appeared in Figure 23 (total rig time = 355:49 hours) after the right nacelle had been removed from the system during the left nacelle gear development process. These side bands also appeared on the 2nd, 3rd and 4th harmonics of the tee box bevel gear. It may be reiterated at this time that the existence of side bands is indicative of an eccentricity or misalignment condition. It is evident from these spectrograms that the removal of the right nacelle resulted in some kind of change in the system. Figure 24 (endurance time = 21:15 hours) also shows the existence of multiple side bands after the right nacelle has been reinstalled in the system. The basic

Figure 23. Amplitude vs. Frequency Spectrogram, Recording No. TC22-1B, Microphone No. 2, (Tee Box), $N_2 = 7000$ RPM, Right Nacelle Not Installed, Total Rig Time = 355:49 Hrs.

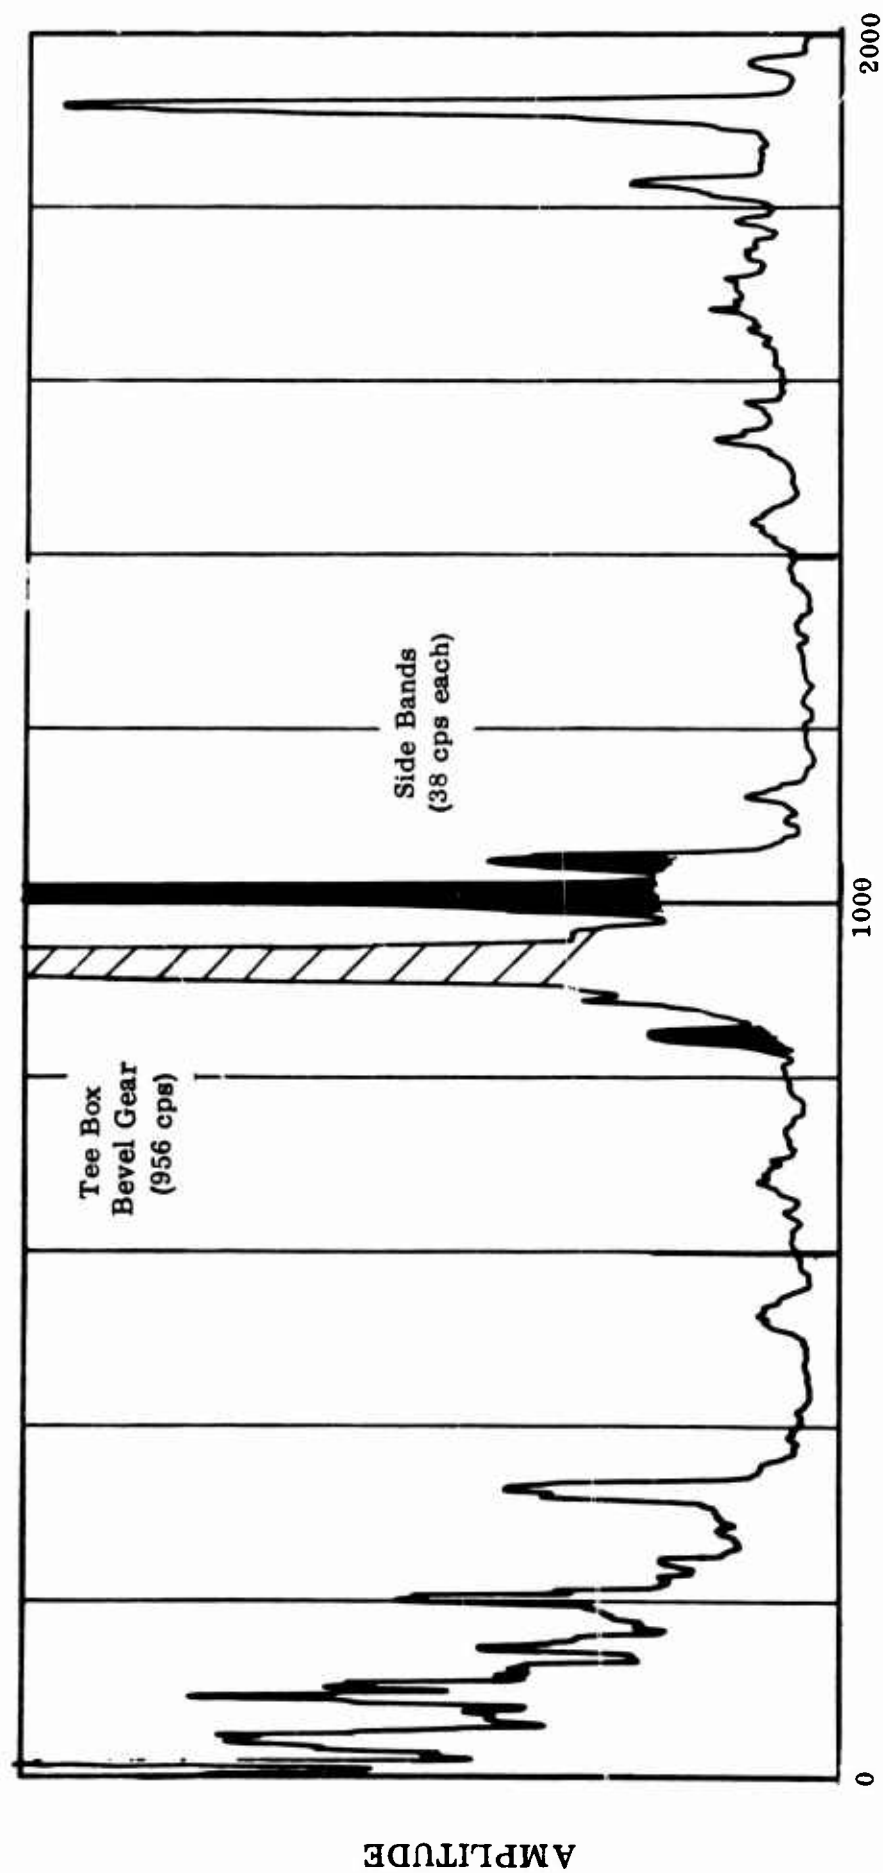
Figure 24, which was made from a recording taken at 6:50 hours before the tee box gear failure, is in itself not an indication of an impending failure but rather an indication of a nonuniformity which possibly imposed a stress on the bevel gear train.

Figure 24. Amplitude vs. Frequency Spectrogram, Recording No. TC26-1B, Microphone No. 2, (Tee Box), $N_2 = 7000$ RPM, Total Rig Time = 384:55 Hrs., Endurance Time = 21:15 Hrs.

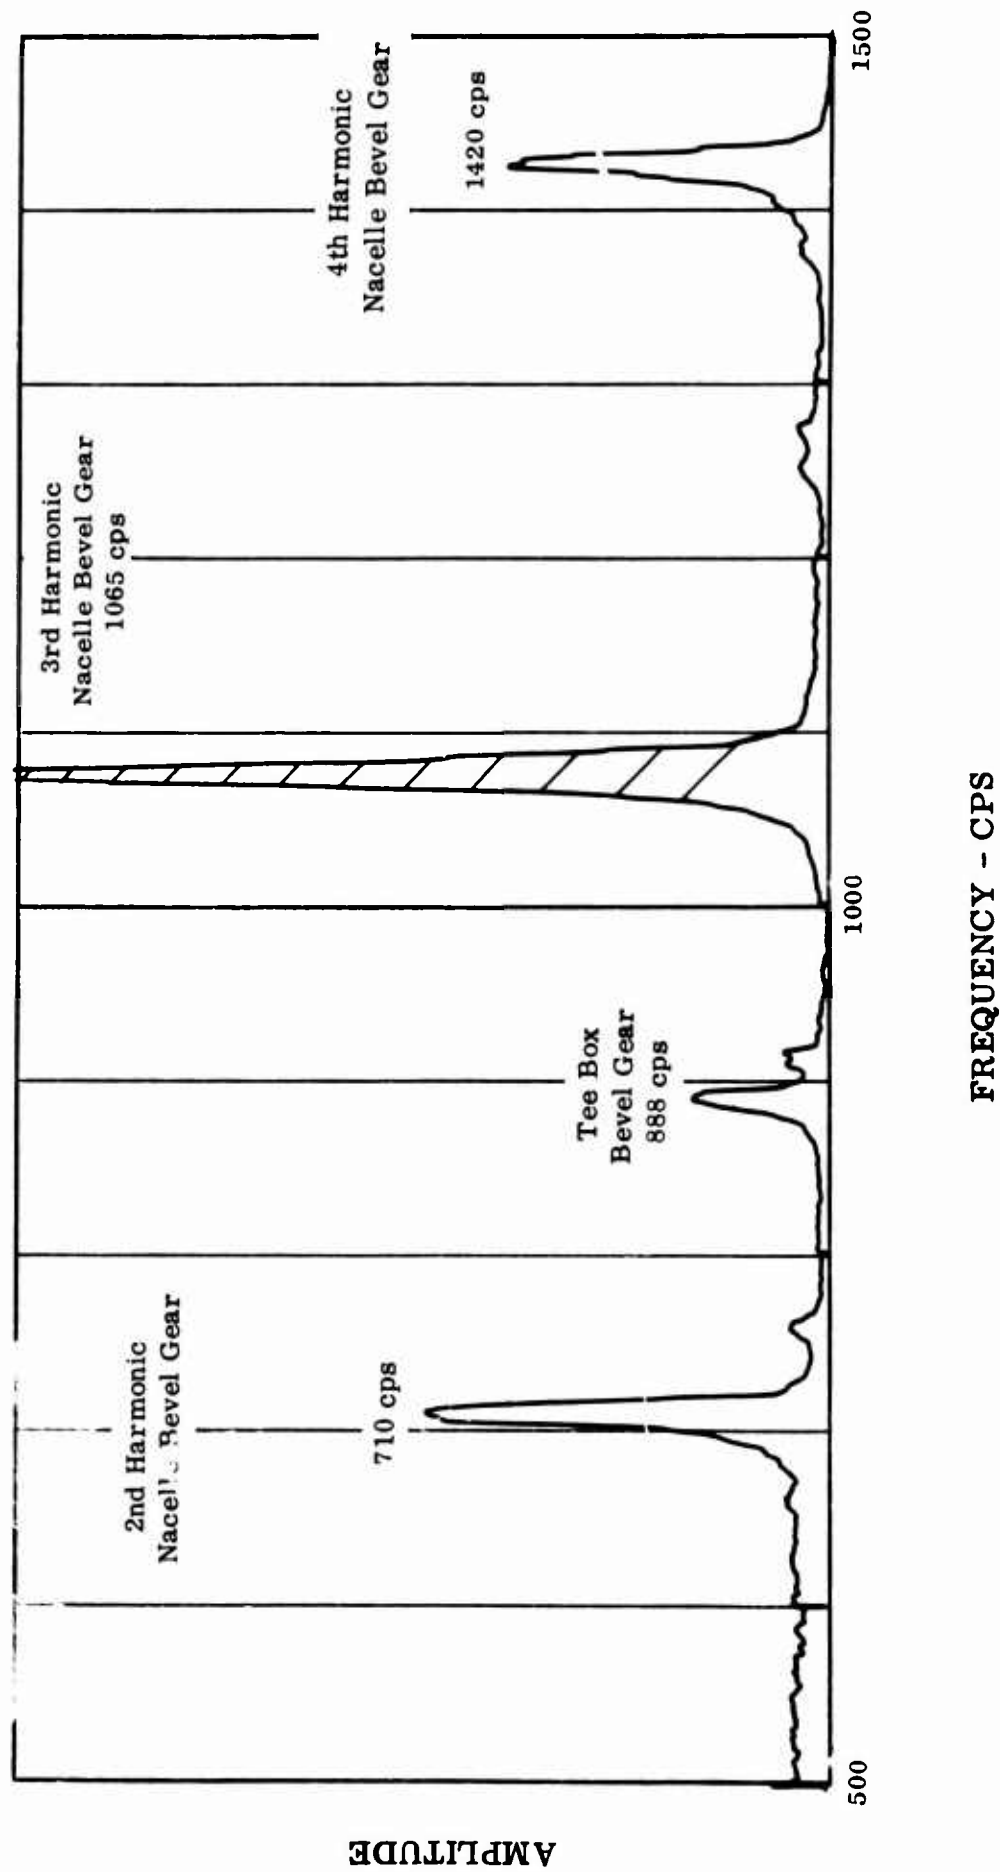
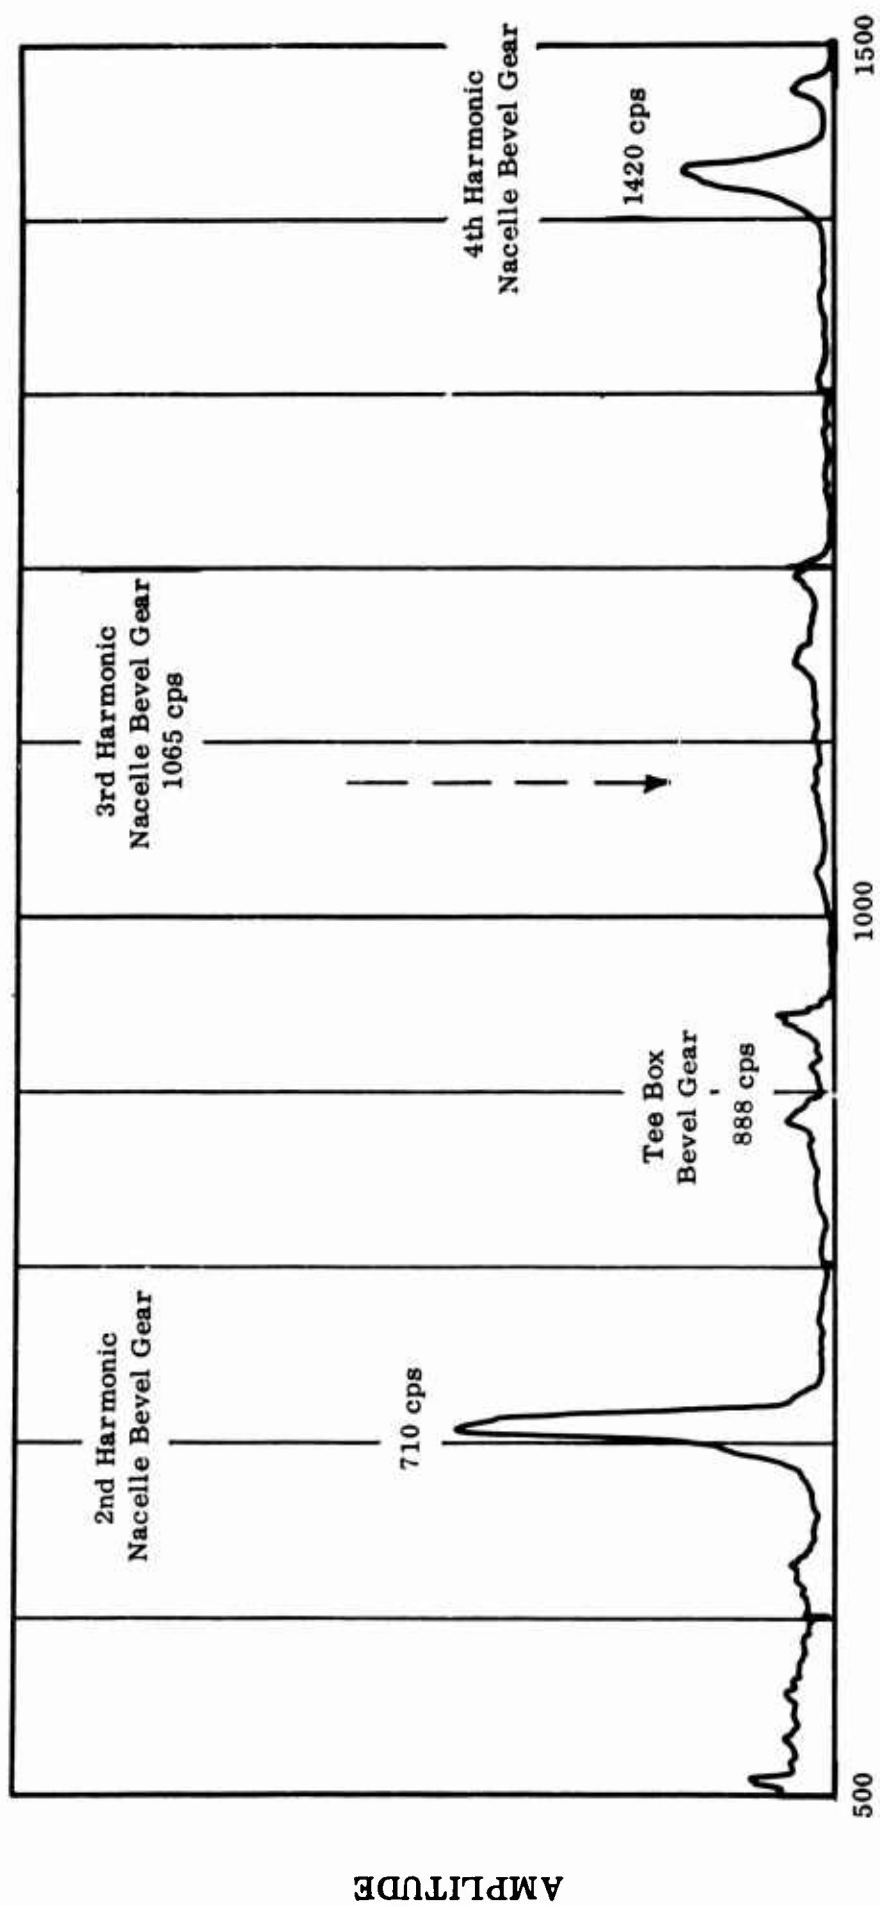
An analysis of Figures 25 and 26, together with the results of the mechanical condition of the nacelles, led to the conclusion that the absence of the 3rd harmonic in the right nacelle spectrogram (Figure 26) was indicative of a difference in the tooth contact pulse shape.

After 50 hours of endurance testing, spalling of the right nacelle bevel gear set showed an acoustic pattern similar to that in Figure 26, in which the 3rd harmonic of the bevel gear mesh frequency disappeared. The light pitting of the left nacelle gear set was not indicated in the spectrograms.

Figure 25. Amplitude vs. Frequency Spectrogram, Recording No. TC19-4A, Microphone No. 3, (Left Nacelle), $N_2 = 6500$ RPM, Total Rig Time = 347:43 Hrs.

Figure 26. Amplitude vs. Frequency Spectrogram, Recording No. TC19-4B, Microphone No. 4, (Right Nacelle), $N_2 = 6500$ RPM, Total Rig Time = 347:43 Hrs.
